Mechanical & Hardgoods Laboratory		Report No.:	THD0258/2015		
		Page:	1 of 7		
		Date:	JAN. 11, 2016		
GIATEX CYCLE CO	O., LTD.				
6F., No.21, Aly. 29, Ln	a. 372, Sec. 5, Zhongxiao E. Rd., Xinyi Dis	st., Taipei City 110, Ta	aiwan		
The following merchs	andise was submitted and identified by t	he annlicant as:			
Product Description:	Adjustable stretching bicycle frame	are applicant us.			
Style/Item No.:	FIT 20				
Sample Quantity:	4 pcs of frame				
	bmitted sample(s) as requested and the				
Test Requested:	For compliance with Clause 4.8.2, Clause

4.8.6 of ISO 4210-2:2015 Cycles - Safety requirements for bicycles - Part 2:			
	Requirements for city and trekking, you	ng adult, mountain ar	id racing bicycles.		
Test Method:	According to Clause 4.1. Clause 4.2. Clause	ause 4.3. Clause 4.4.a	nd Clause 4.5 of ISO		
rest wiethou.	According to Clause 4.1, Clause 4.2, Clause 4.3, Clause 4.4 and Clause 4.5 of ISO 4210-6:2015 Cycles - Safety requirements for bicycles - Part 6: Frame and fork test				
	methods.	its for bieyeles Tart	o. I fulle und fork test		
Bicycle type:	■ City and trekking ☐ Young adult	☐ Mountain ☐	Racing		
C	Carrala Na 1, Class A A a GIGO 4010 C				
Sequence of Testi

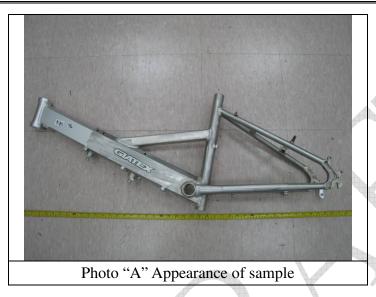
- Picture(s) -

Test clause	Test condition Drop height, h ₁ (mm)	Requirement	Test Result
Clause 4.1.2 (ISO 4210-6)	180	< 10 mm (Dummy fork)	6.4 mm
Remark	There was no visible crack on the sample after testing.

•	i iciaan i mamg.		ACIES.		
	Test clause	Test condition		Requirement	Test Result
	Clause 4.2.2 (ISO 4210-6)	Seat post, M ₁	50 kg		
		Steering head, M ₂	10 kg	< 60 mm	9.0 mm
		Bottom bracket, M ₃	30 kg	< 00 11111	9.0 111111
		Drop height, h ₂	200 mm		
	Remark	There was no visible crack on the sample after testing.

Violani.	100000	
Test clause	Test conditions			Test Result
	Force (F ₁)	Frequency	Cycles	(Cycles)
Clause 4.3.2 (ISO 4210-6)	1,000 N	3 Hz	100,000	100,000
Remark	There was no visible crack on the sample after testing.

rictual i mams.			Anny.	
Test clause	Test conditions			Test Result
	Force	Frequency	Cycles	(Cycles)
Clause 4.4.2	450 N (F ₂)	2 11-	100,000	100,000
(ISO 4210-6)	450 N (F ₃)	3 Hz	100,000	100,000
Remark	There was no visible crack on the sample after testing.

Test clause	Test conditions		Test Result	
	Force (F ₄)	Frequency	Cycles	(Cycles)
Clause 4.5.2	1 000 N	3 Hz	50,000	50,000
(ISO 4210-6)	1,000 N	э пх	50,000	50,000
Remark	There was no visible crack on the sample after testing.
